Cyanides Disaster on Bečva River Discovery

Jiří Klicpera

ABSTRACT

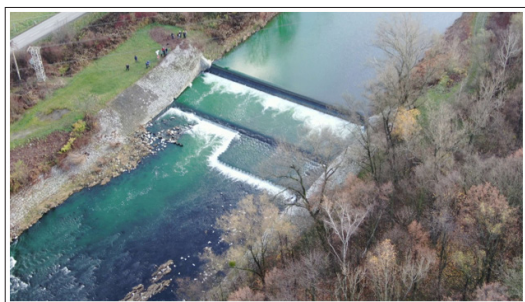
For evidence it was first necessary to determine the transport time of toxic substances in the river from the sewer outlet to the place where the accident had been identified. I carried this out using a non-toxic coloured tracer (fluorescein). However, it was necessary to wait almost two months for the lowest possible river flow. In the meantime, I investigated by the treatment plant operator, hydrobiological and chemical inspections at the plant, and experienced COVID-19 for the first time. Additional measurements determined the inflow time from the suspected location responsible for the accident so that the time of the accident in the treatment plant operation could be specified as precisely as possible. During the investigation the treatment plant operator absolutely refused any cooperation other than that ordered by the Police. This put the operator conflicted with the Czech Water Act, which requires cooperation.
